## TOTAL THICKNESS AND COMPACTION REQUIREMENTS FOR FLEXIBLE PAVEMENTS TO BE SUBJECTED TO CHANNELIZED TRAFFIC

TECHNICAL REPORT NO. 3-610

November 1962

U. S. Army Engineer Waterways Experiment Station  
CORPS OF ENGINEERS

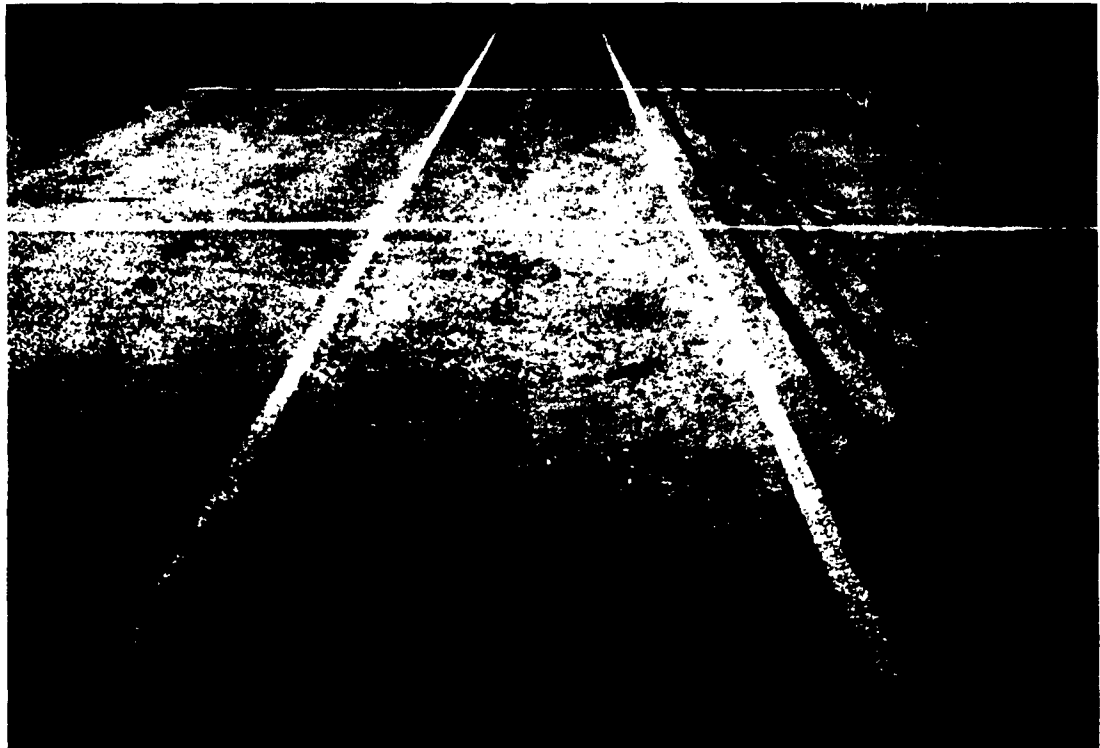
Fig. 7. Test section before traffic

0.4 gal per sq yd for the first coat and 0.3 gal per sq yd for the second coat. Limestone chips (3/4-in. maximum size) were spread at the rate of 35 lb per sq yd for the first coat; for the second coat, smaller limestone chips (3/8-in. maximum size) were spread at the rate of 25 lb per sq yd. The double surface treatment was compacted by 20 coverages of a wobble-wheel roller loaded to 10,000 lb and 10 coverages of a tracking rig with 25,000-lb wheel load and 200-psi tire inflation pressure. Fig. 7 shows the completed test section before traffic.

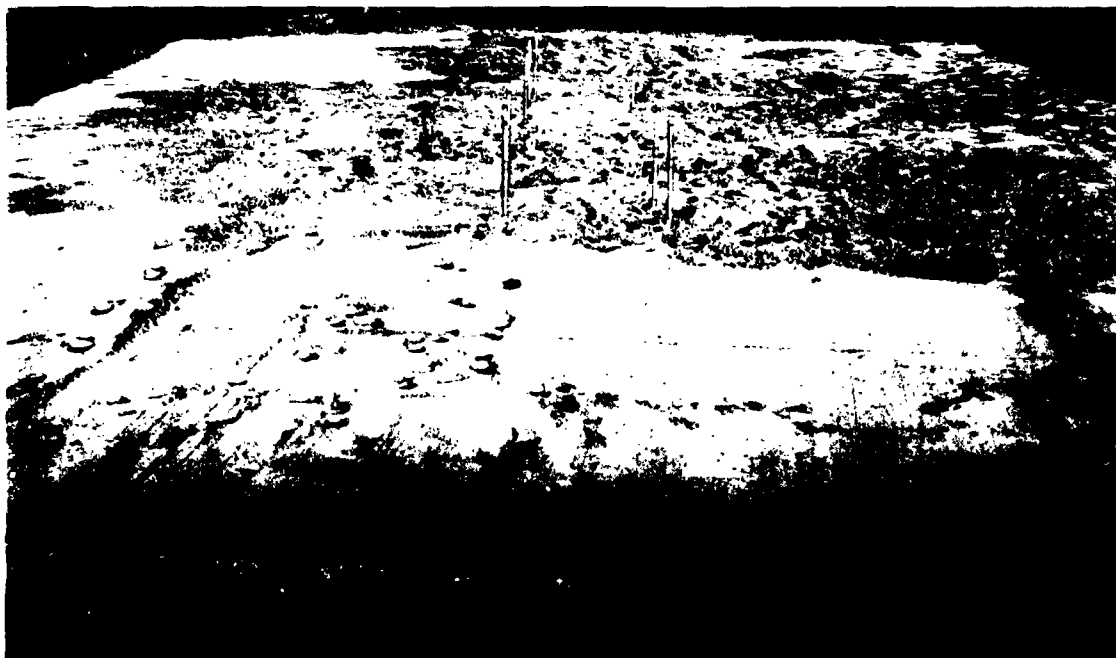
Fig. 10. Settlement plates installed in the sand subgrade of item 4

15. Sixteen settlement plates, such as shown in fig. 9, were placed at eight elevations in the sand subgrade of item 4. Two plates each were located at the surface of the subgrade and at about 1-ft increments to a total depth of 7 ft. Due to difficulties in placing and compacting the sand fill around the pipes, five of the plates were destroyed during construction. The two rows of pipes leading from the settlement plates were 3 ft apart. The traffic lane was to be centered over these two rows of plates so that deformations measured at any plate

would be comparable, as each plate was located at the same lateral offset from the center line of the traffic lane. The plate elevations were determined to the nearest 0.01 ft on a level rod which had been lowered inside the hollow iron pipe leading from each plate to the surface of the subgrade. Fig. 10 shows item 4 with the settlement plates installed after 6 ft of the 8-ft sand fill had been placed.

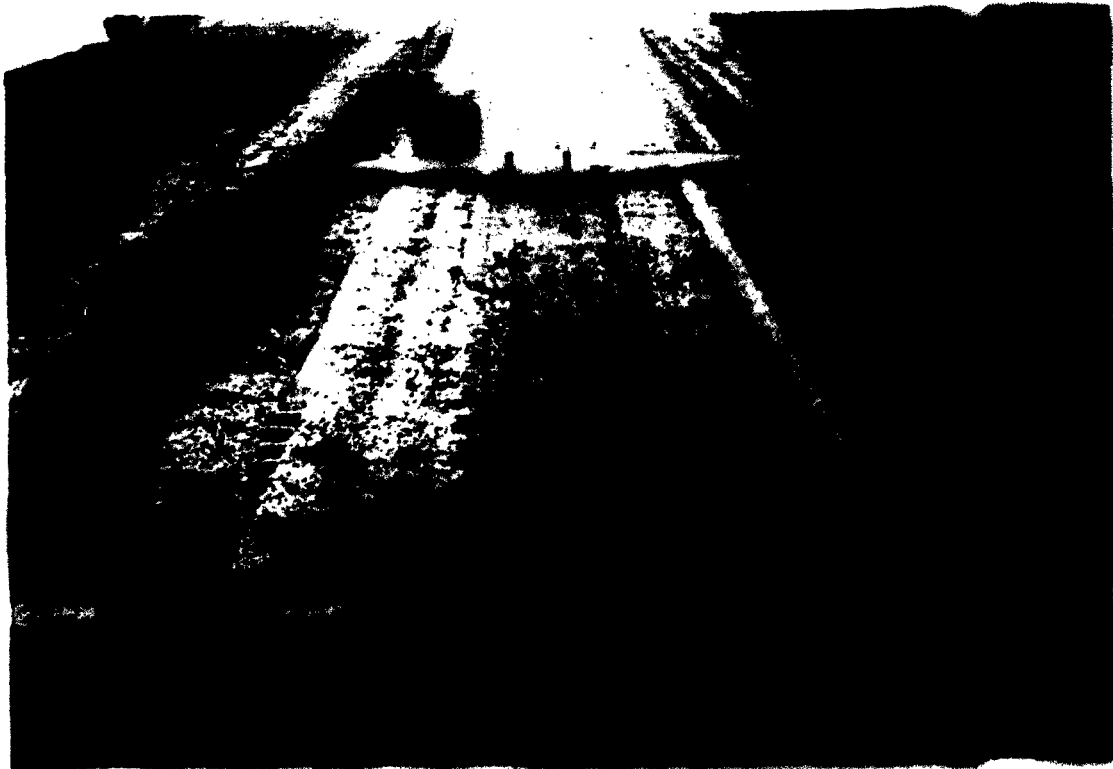
24. The general condition of items 1 through 4 was very good at the end of 9142 coverages of traffic with the 100,000-lb gear load (see photographs 1 through 4, respectively). At this stage of traffic, test pits were excavated in each test item and in-place CBR, water-content, and density determinations were made in the various elements of the structure. The results of these tests are included in table 1. These data show that

Photograph 1. Item 1 at the end of phase 1 traffic

Photograph 2. Item 2 at the end of phase 1 traffic

Photograph 3. Item 3 at the end of phase 1 traffic

Photograph 4. Item 4 at the end of phase 1 traffic

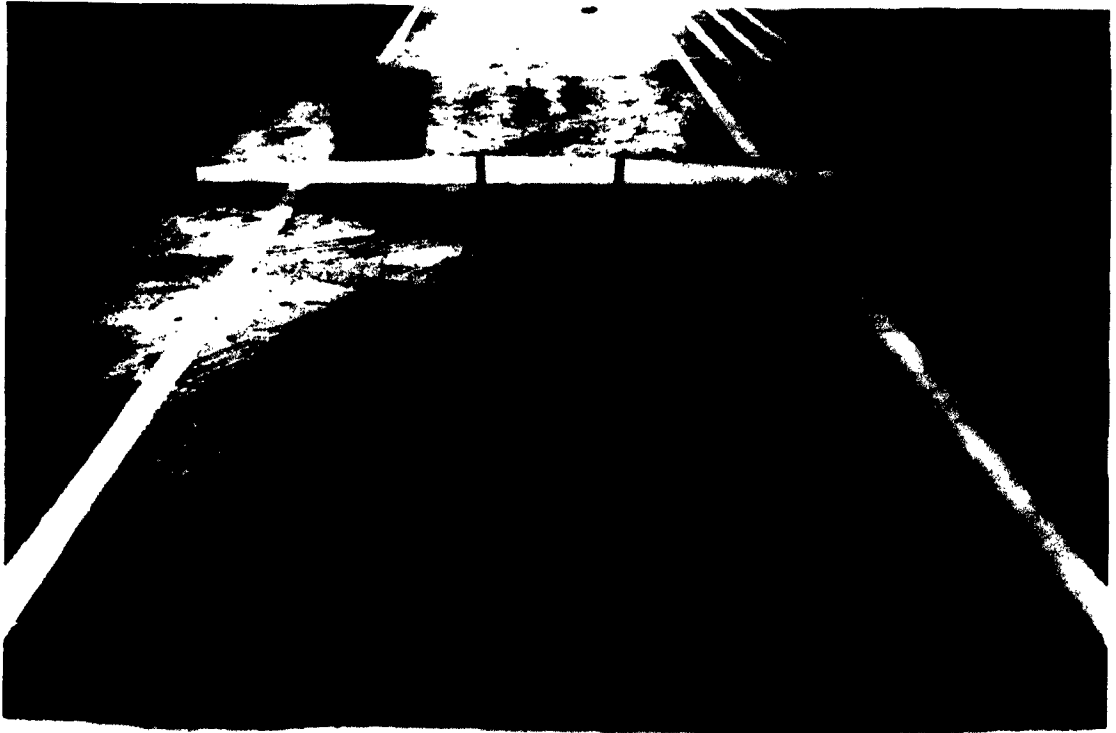
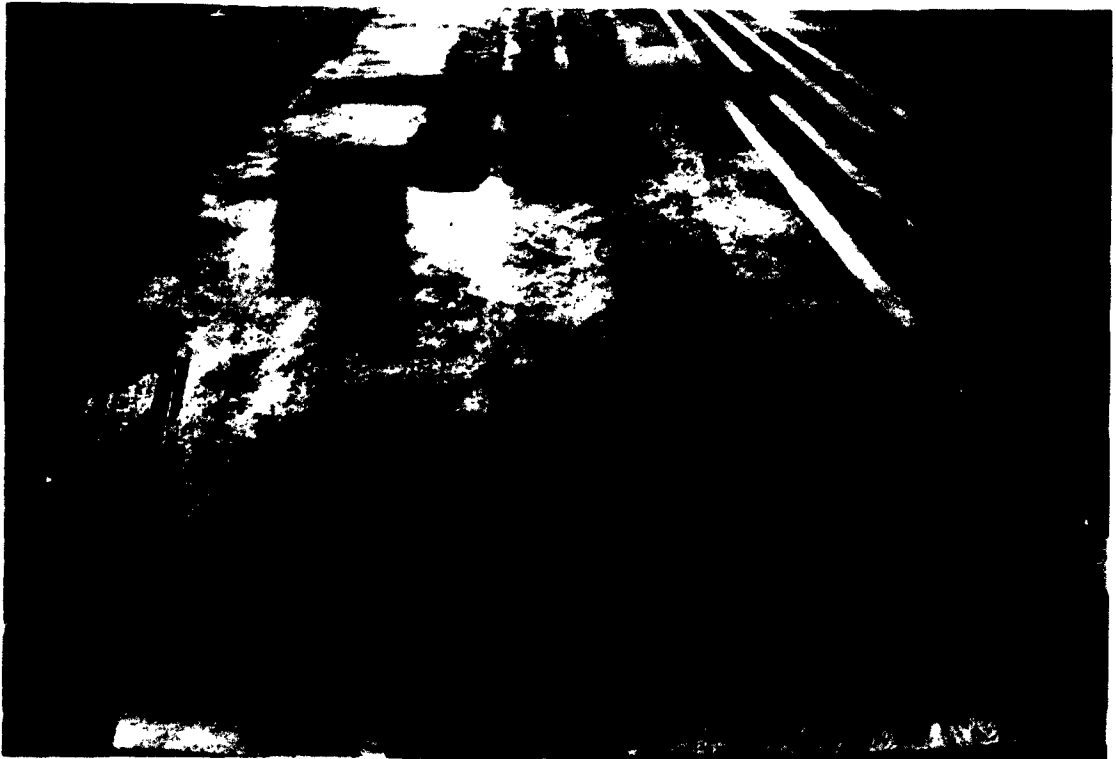
other cracks developed. One of the cracks at the end of 4000 coverages of traffic is shown in photograph 5; this crack extended fairly deep into the base course. Intermittent longitudinal tension cracks also developed about 18 in. outside the traffic lane, parallel to direction of traffic, in test item 4. These cracks were on each side of the traffic lane, and were first observed at about 400 coverages. By 4000 coverages they were quite pronounced, as shown in photograph 6. By 4572 coverages of traffic, the surface of the pavement had become slightly rough due to abrasion, and it was thought that the occasional pieces of protruding aggregate might be a contributing factor to the frequent tire failures that were occurring. Also, the settlement in item 4 was quite severe with an average deformation in the traffic lane of about 2 in. To correct this condition, a leveling course of crushed-stone base material was applied over item 4, and a layer of sand asphalt about 1/2 in. thick was applied over the entire traffic lane. The sand asphalt was slightly rich and remained soft and pliable throughout the remaining period of traffic. Phase 2 traffic was continued up to a total of 10,496 coverages. During this period the cracks which were observed earlier in item 3 did not show through the sand-asphalt surface. Items 1 through 4 at the end of 10,496 coverages are shown in photographs 7 through 10.

Photograph 7. Item 1 at the end of phase 2 traffic

Photograph 8. Item 2 at the end of phase 2 traffic

Photograph 9. Item 3 at the end of phase 2 traffic

Photograph 10. Item 4 at the end of phase 2 traffic

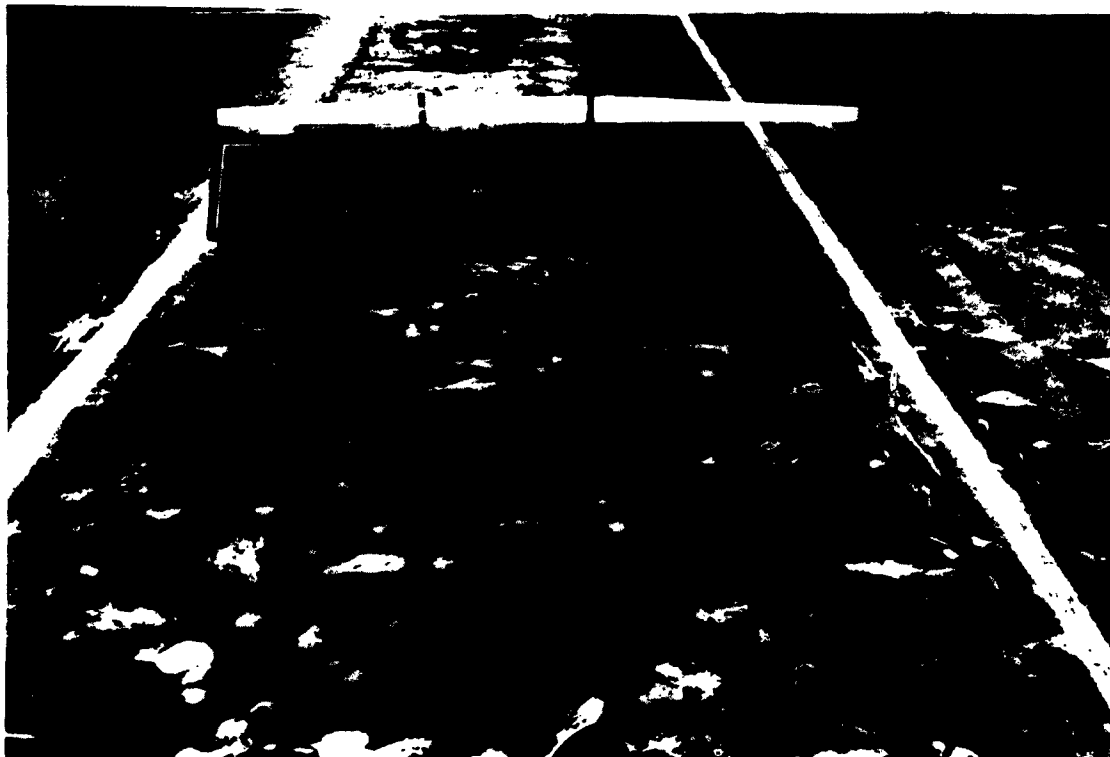
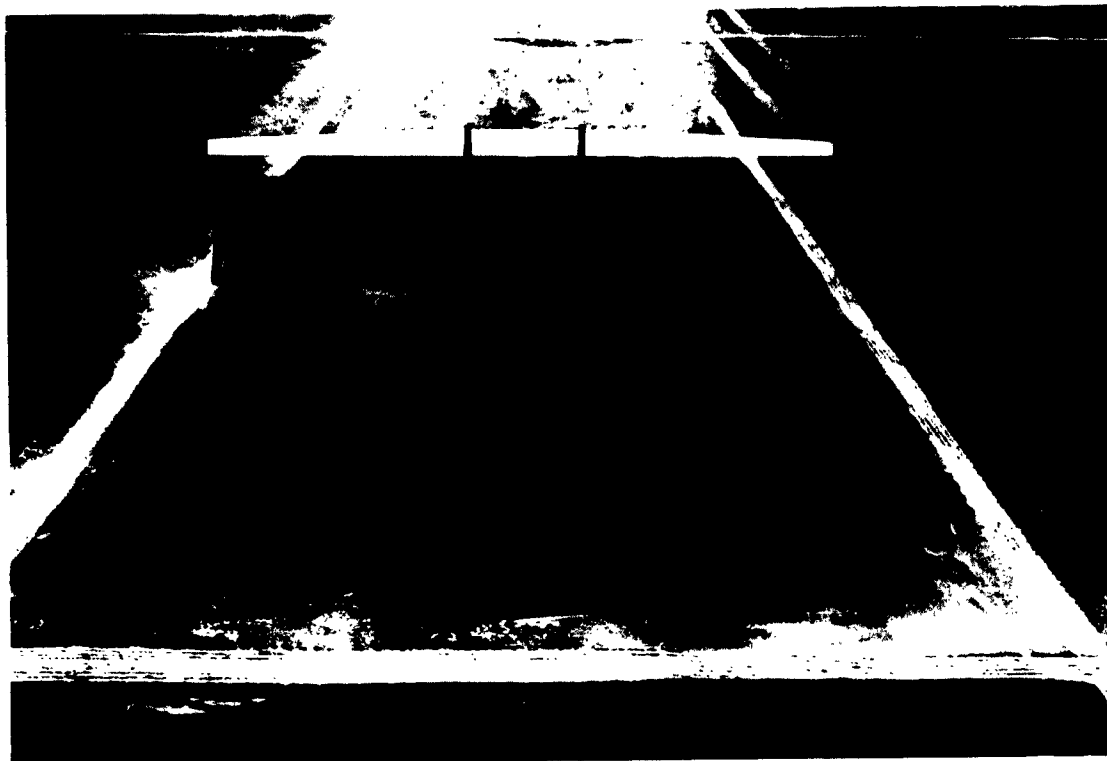
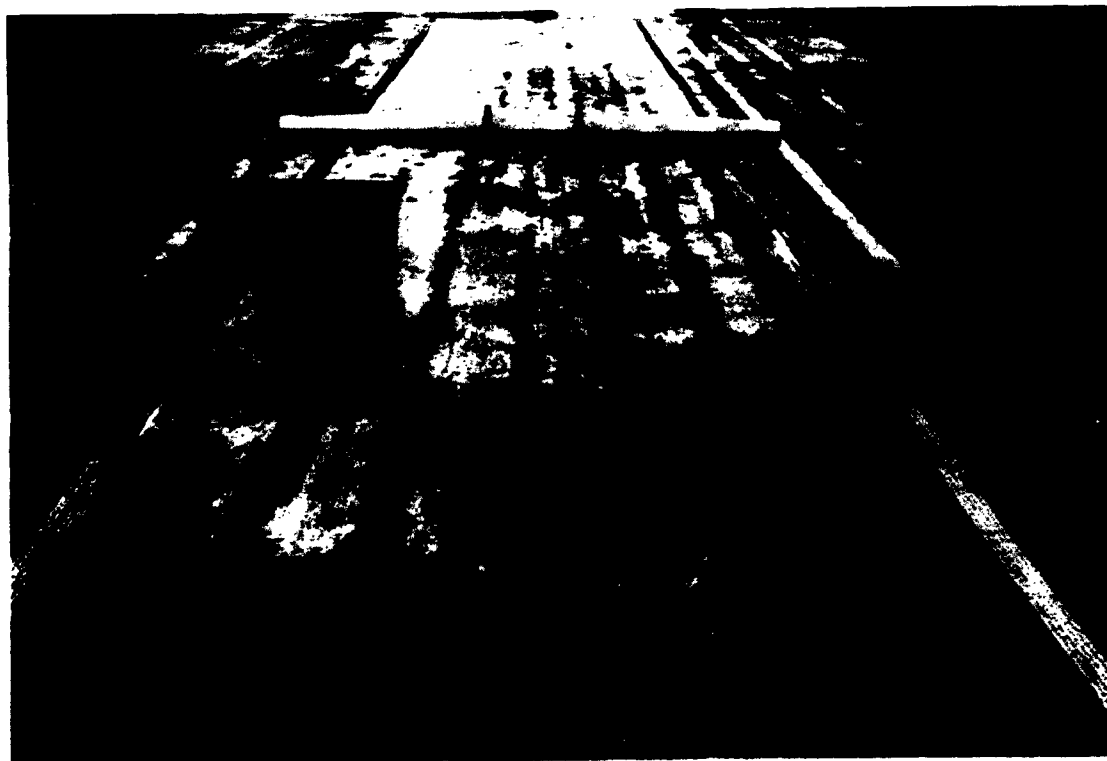
31. A total of 7186 coverages of traffic with the 150,000-lb twin-wheel load were applied during phase 3. Test items 1 and 2 performed satisfactorily throughout this period of traffic. Item 3 was considered a borderline case due to cracking which developed during the early stages of this phase. The first crack in item 3 appeared at about 1300 coverages of traffic and by 5000 coverages, four cracks extended across the traffic lane. One of the cracks at the end of 5743 coverages is shown in photograph 11. There was no apparent change in the extent of cracking between 5000 and 7186 coverages of traffic. The cracking did not appear to affect the load-carrying capacity of the pavement but was considered severe enough to have caused cracking in an asphaltic concrete surfacing. Therefore, the item was rated as border line. Items 1, 2, 3, and 4 at the end of 7186 coverages are shown in photographs 12 through 15, respectively.

Photograph 12. Item 1 at the end of phase 3 traffic

Photograph 13. Item 2 at the end of phase 3 traffic

Photograph 14. Item 3 at the end of phase 3 traffic

Photograph 15. Item 4 at the end of phase 3 traffic
